Australian Government
Department of Defence
Defence Science and
Technology Organisation

F-111 Adhesive Bonded Repairs Assessment Program - Progress Report 2: Analysis of FM300-2K Repairs

DSTO-TR-3088

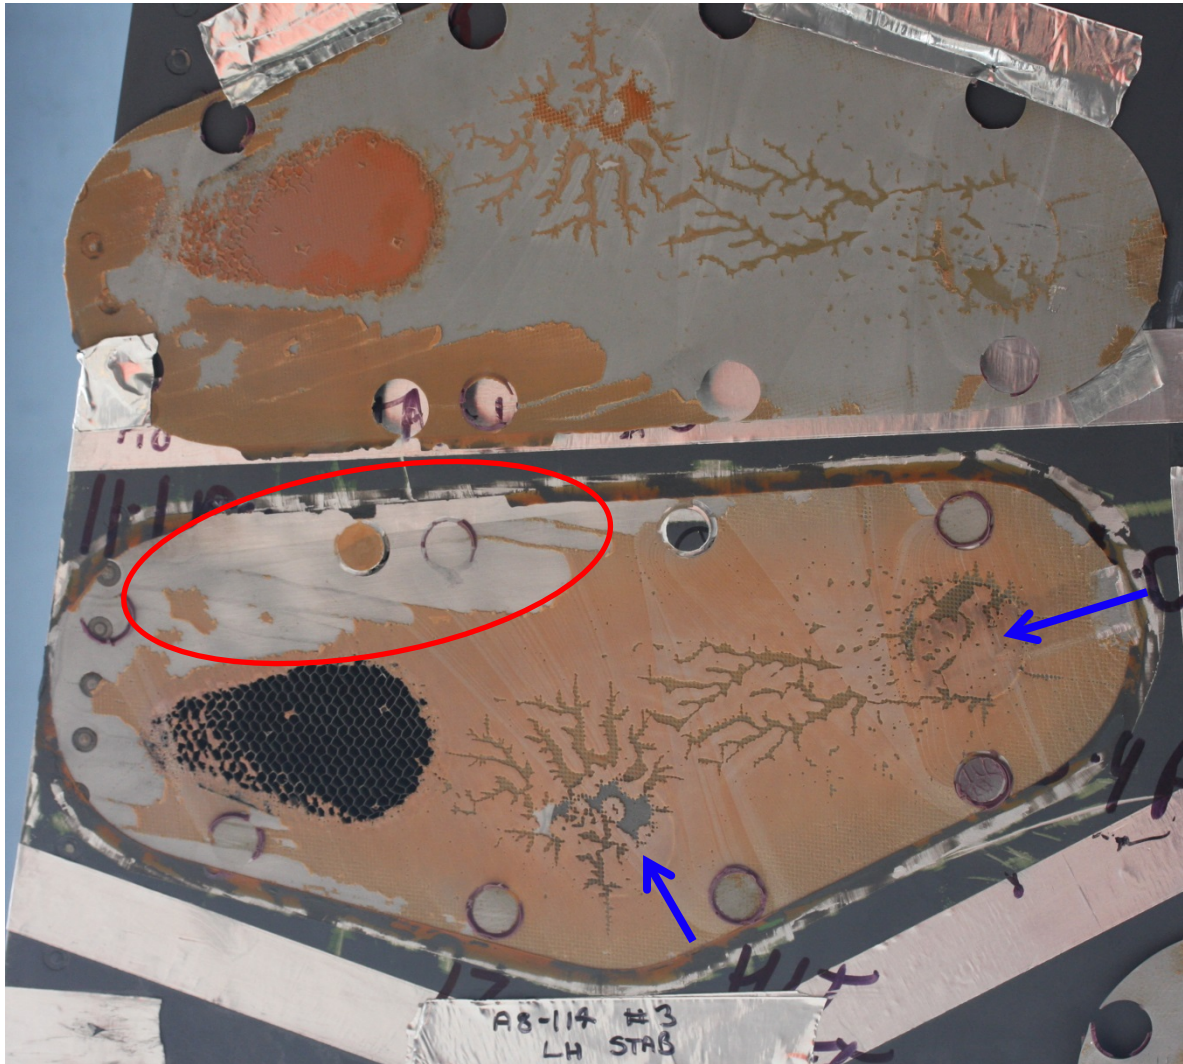
Figure 11 Repair 114-3 shows heavy voiding emanating from some of the areas of repaired core, indicated by the blue arrows. This is characteristic of inadequate drying following cleaning. The area along the top left of the repair, encircled in red, has an uneven appearance with shiny areas indicating insufficient gritblast.

Amongst the lowest strengths observed were stubs for which there were apparent adhesive wetting problems, highlighted in blue in Table 3. The example shown in Figure 11, in addition to heavy voiding, also appears to have had problems with wetting, most noticeably on the left side. Cases where the adhesive has not wetted either the doubler or aircraft skin are normally indicative of inadequate vacuum pressure being applied during the repair. It is more difficult to obtain good vacuum pressure close to the edge of a

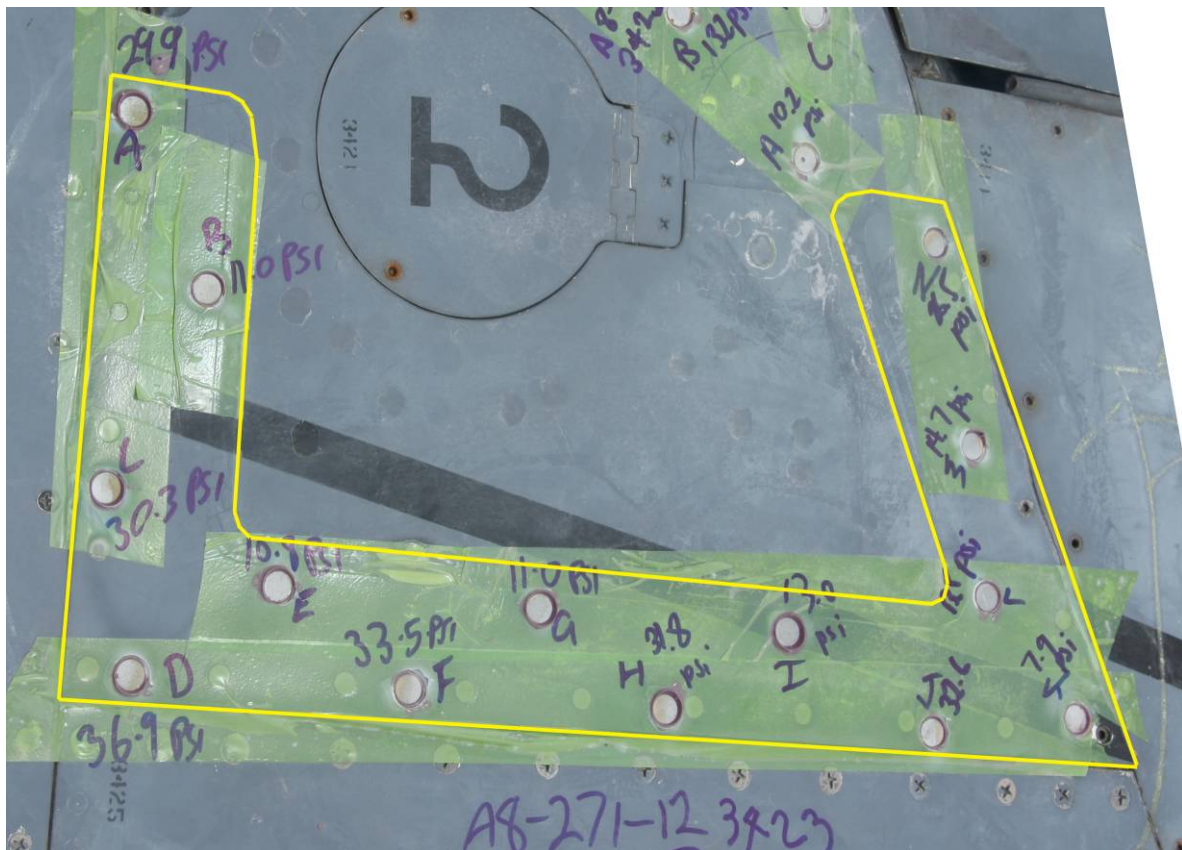
Figure 13 Repair 271-12, on aircraft A8-271, panel 3423

Repair number 271-12, made using FM300-2K, was chosen for closer inspection as a case study, as it had low and high strength stubs, and several stubs had a particularly unusual appearance. Figure 13 shows the repair, on panel 3423, outlined in yellow. Table 5 shows the strengths of the stubs on repair 271-12.

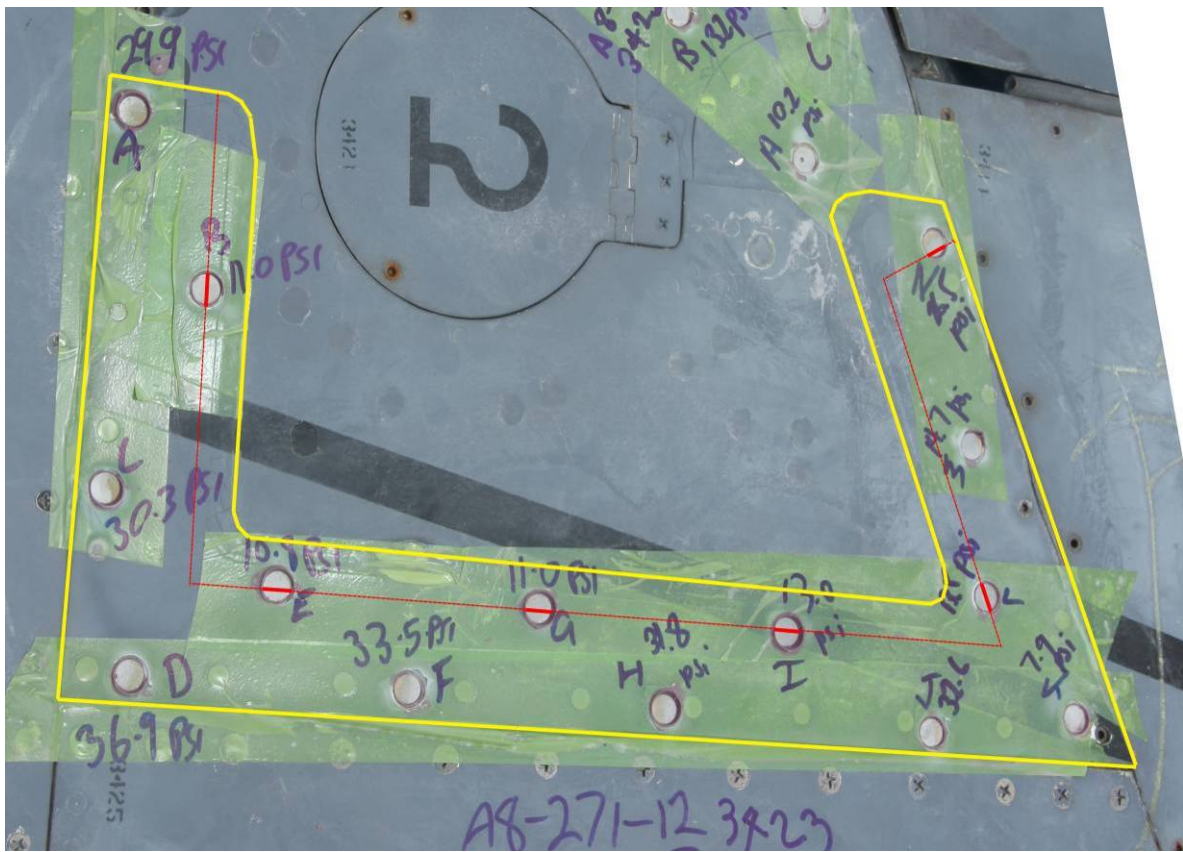
When all these green tape residue lines are marked out, as annotated in red on the photograph of the repair in Figure 15, it becomes apparent that the repair area had been marked out for cleaning, but that at some stage it was decided to enlarge the repair area. It appears that the additional repair area was not cleaned as thoroughly as necessary, as the green tape line should have been easily removed by wiping with a solvent-dampened tissue. If the enlarged repair area was not cleaned properly, it would explain why the above-mentioned stubs all had a lower measured strength than the other stubs on the same repair.

Figure 15 Repair 271-12, on aircraft A8-271, panel 3423, with tape residues annotated in red

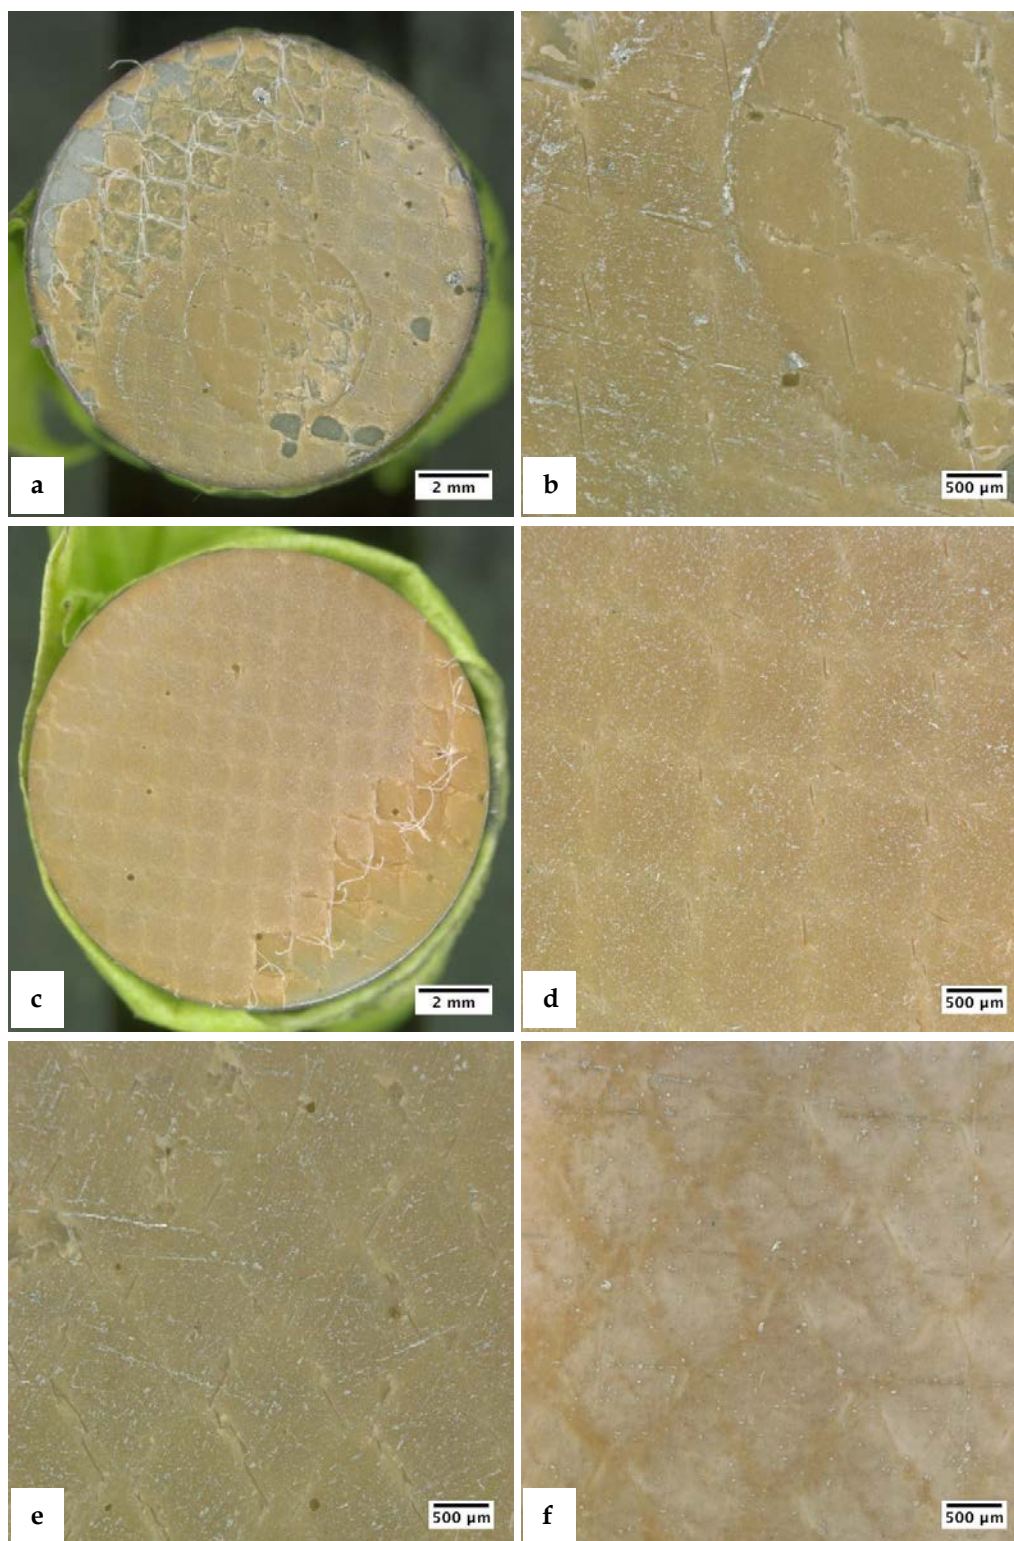
*Figure 16a) & b) Failure surface of stub 271-12J, which had high strength
c) & d) Failure surface of stub 140-07A, which had low strength
e) Failure surface of stub 271-12B, which had low strength
f) Failure surface of a requalification wedge test*

When stub 271-12B was examined in more detail (Figure 16e), it became evident that the metallic powder and lines are debris left over from the Scotchbrite abrasion step of the cleaning process. By comparison, stub 271-12J (Figure 16a and b) was a high strength stub, incidentally located over a rivet. The area bonded to the rivet head appears quite clean, with much less abrasion debris. The partial rings of debris on one side of the rivet suggest that the rivet was in place during cleaning, and the debris collected around the edge of the rivet. Later cleaning may have dislodged some of the debris, but did not completely remove it. The rivet may have had a higher hardness than the aircraft skin, which would make it more difficult to abrade, leaving less debris on the rivet head.

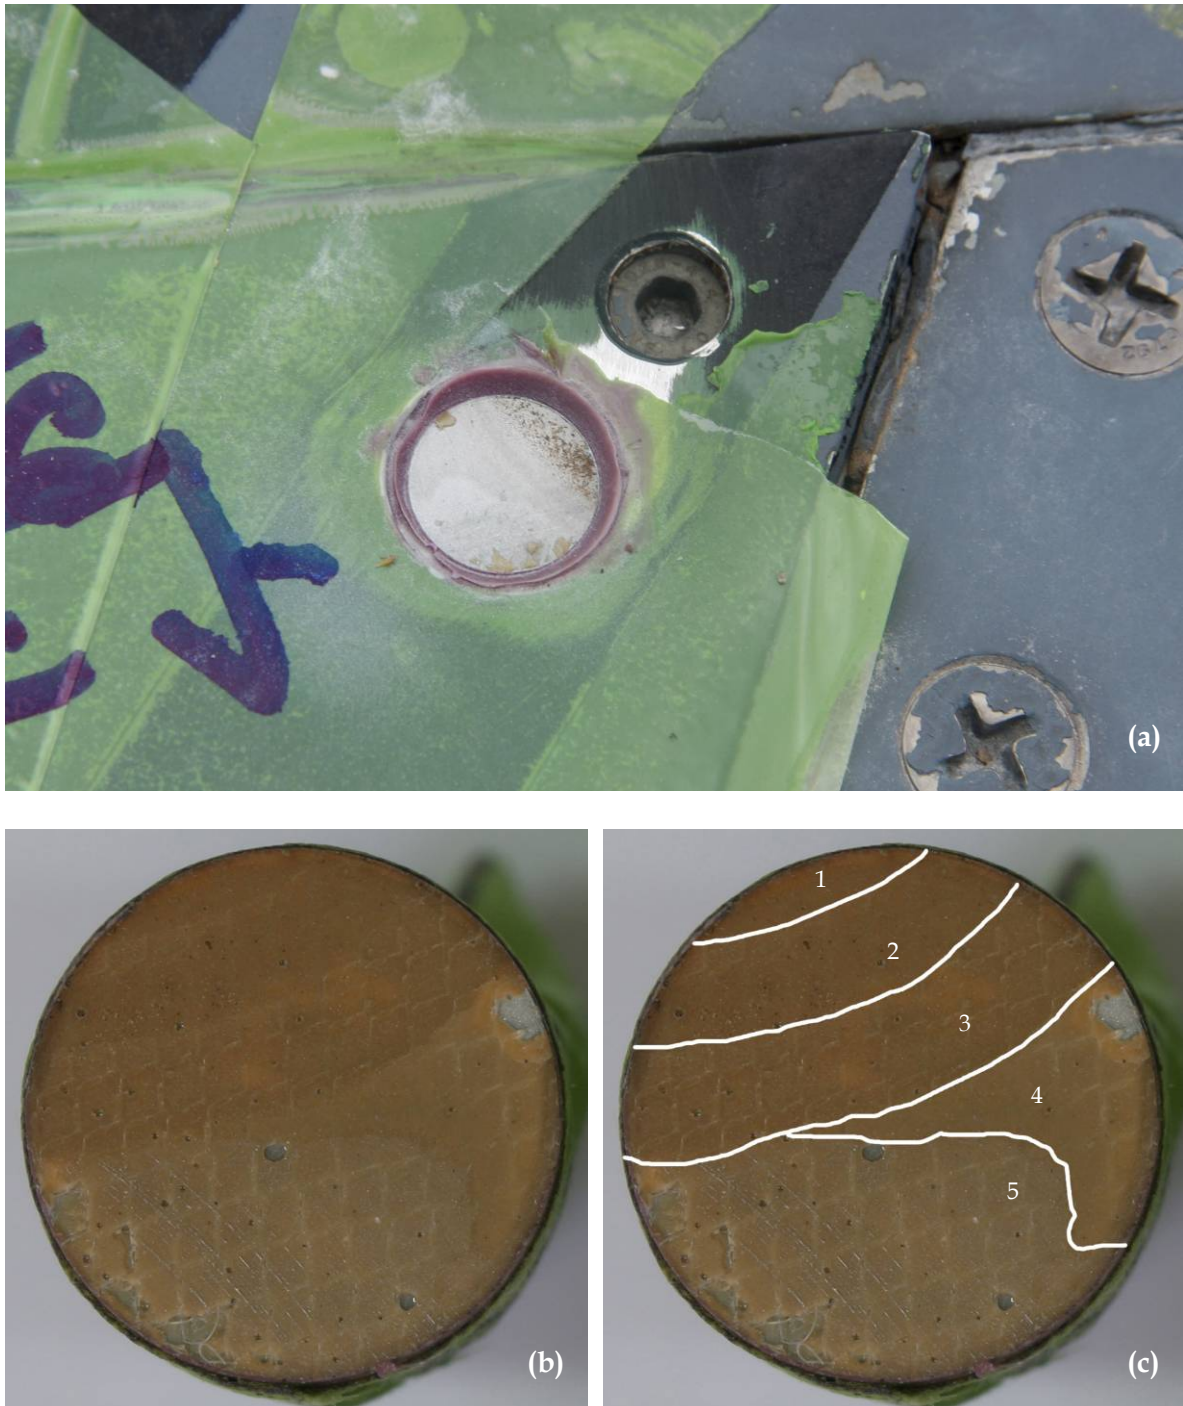
Another stub on repair 271-12K had one of the lowest strengths of all FM300-2K stubs inspected. This one was also examined more closely. Figure 17a and b show the aircraft side and stub side of the failure surfaces, respectively. Both sides appear to exhibit some contamination on parts of the failure surface. Focussing on the stub side, there is clear discolouration of the adhesive. The discolouration may have been caused by oxidation due to exposure to the atmosphere, or more likely, contact with fluid. The colour variation suggests that there were five distinct areas, corresponding to four different exposure events. These five areas are outlined for clarity in Figure 17c. It appears that a delamination may have begun in area 1, then progressed across areas 2, 3 and 4, before the stub finally failed in area 5 due to the PATTI inspection. The delamination may have originated from the fastener hole, and was probably caused and exacerbated by fastening/unfastening operations, however it is possible that there was some contamination of the surface in this area prior to bonding that may have contributed to low initial strength in the localised area, especially as fastener holes are likely to have grease contamination and are difficult to clean. It is unfortunate that the repair doubler was not removed, as the failure surfaces would have revealed more about the mode and cause of failure. Note that the delamination is over a very localised area and would have been discovered by non-destructive inspections before growing to a significant size.

Figure 17 The failure surfaces of test A8-271-12K, showing, (a) the aircraft side, (b) the stub side, and, (c) the stub side with apparent delamination progression zones marked.

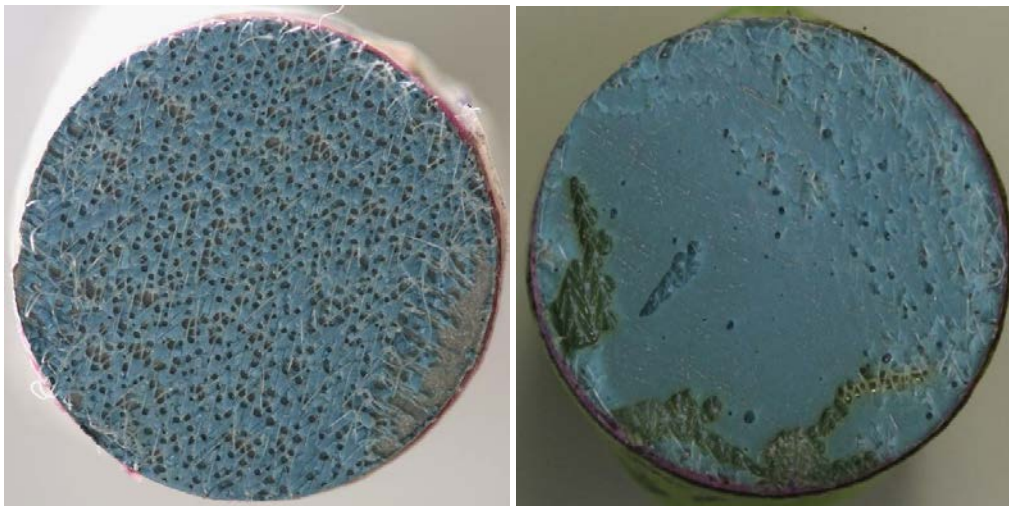
Figure 18 Test stubs A8-143-5J and A8-512-22A

It is also known that FM300-2K is supposed to be staged before use in vacuum-assisted repairs, i.e. the adhesive film is heated to remove volatiles such as solvents or water vapour before being used to bond a repair. However this requirement had not been captured in AAP7201.016-2, which outlines the procedures to be followed in preparation of a bonded repair, and it is known that adhesive staging is not currently being performed. Almost all on-aircraft repairs are cured under vacuum. Excessive volatiles on the bonding surfaces or in the adhesive during curing under vacuum will result in the volatiles being expanded by the vacuum. The FM300 failure surfaces almost all exhibited some level of voiding, but voiding is not so obvious in most of the FM300-2K failure surfaces. A typical FM300 failure surface is shown in Figure 18a, which contrasts with the FM300-2K failure surfaces shown in Figure 16 and Figure 17. Note that the majority of FM300-2K specimens failed at the adhesive/aluminium interface, whereas the FM300 specimens mostly failed cohesively (through the adhesive, away from the interface). Figure 18b shows one of the few FM300 failure surfaces that exhibited adhesion failure, and on closer inspection, silvery lines are visible (as discussed for FM300-2K in Figure 14), but not as easily noticed as the silver blends with the blue colour of the adhesive.
